# **Distribution Construction**

## **Inspection Findings**

New England Pipeline Safety Seminar  
October 20, 2010

Karl Baker – CT DPUC  
Gary Kenny – ME PUC

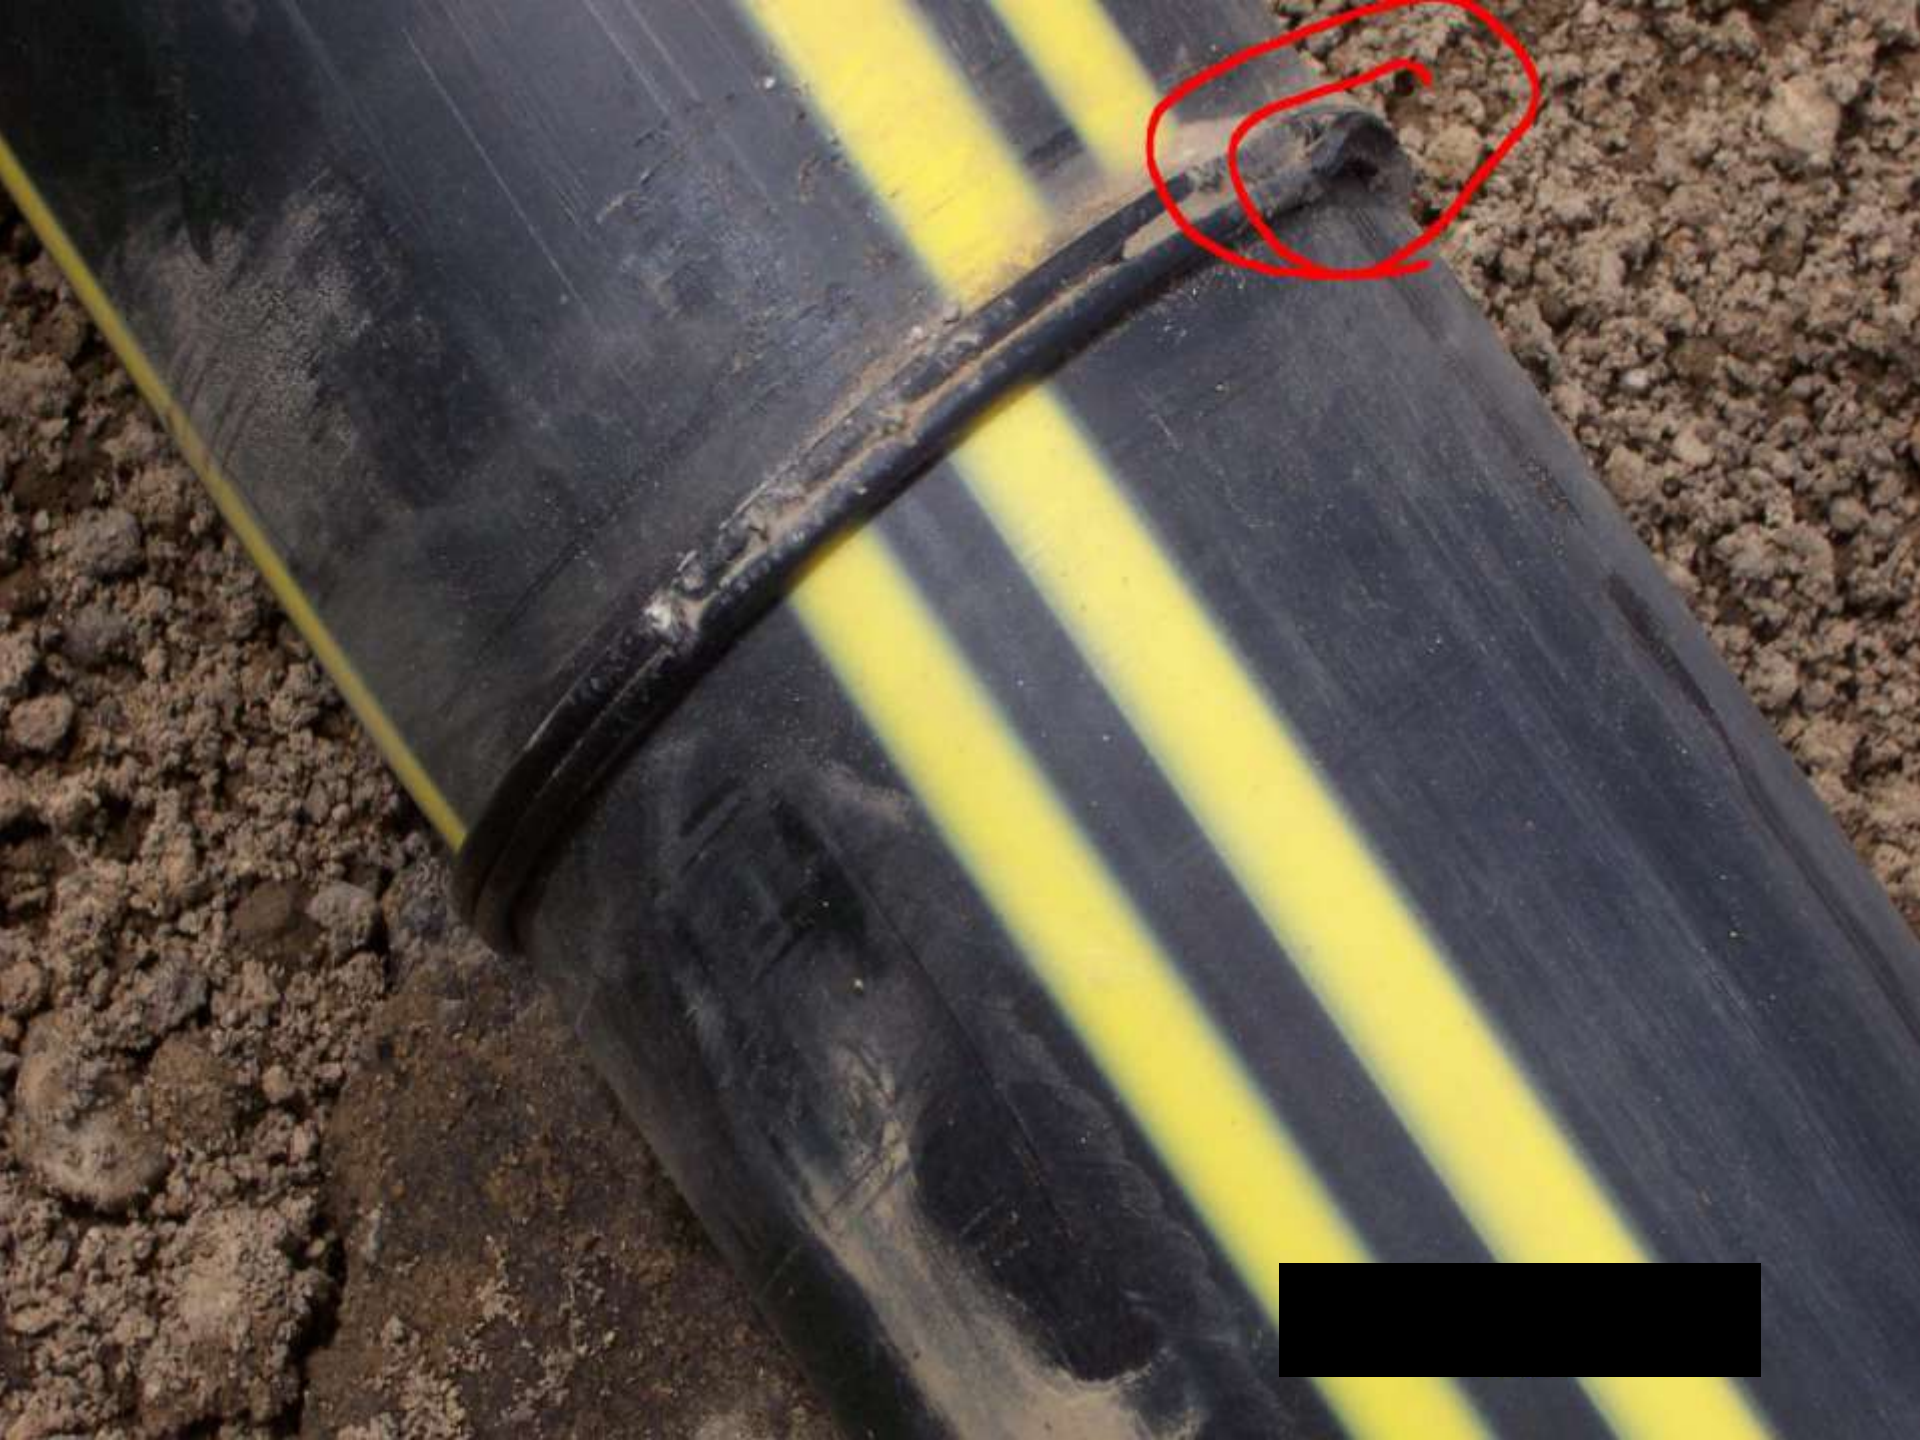
**Right in the  
area to be  
joined...**

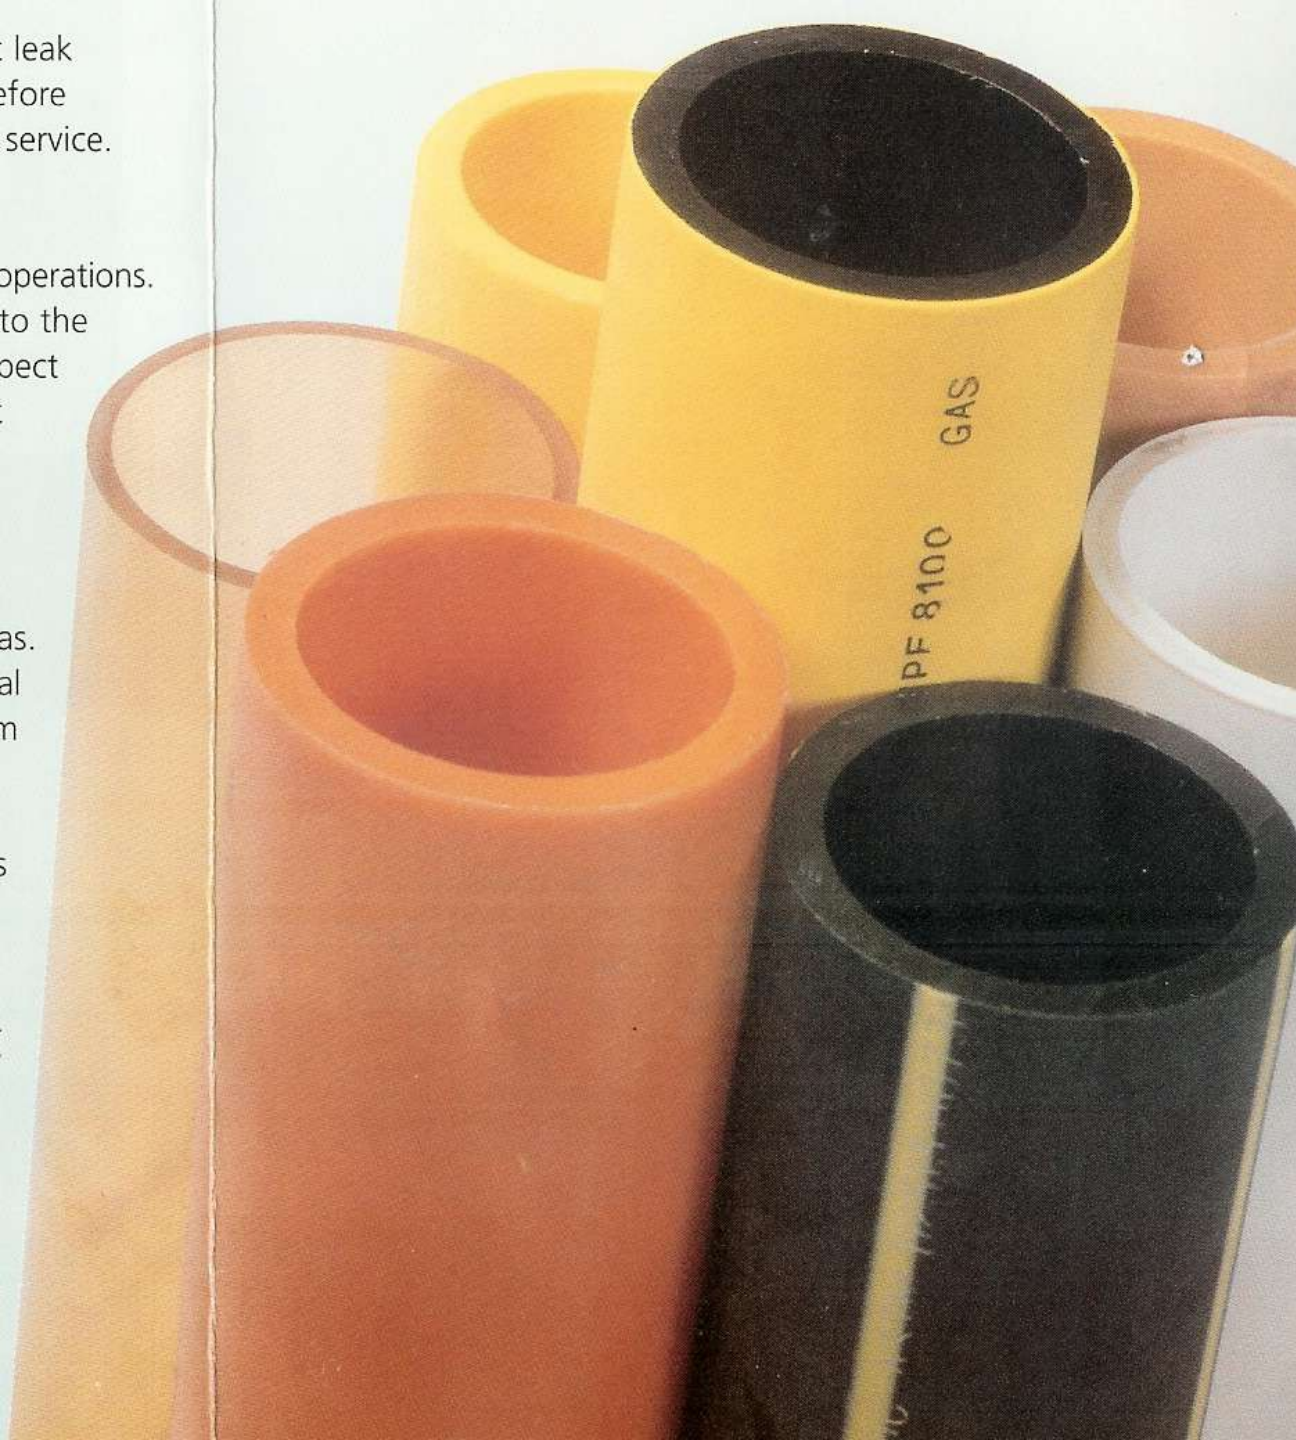
- ▶ **The Operator installed a 2" plastic gas line with a gouge greater than 10% wall loss, the Operator did not know how to measure the defect nor did the Operator have any equipment to measure the defect.**

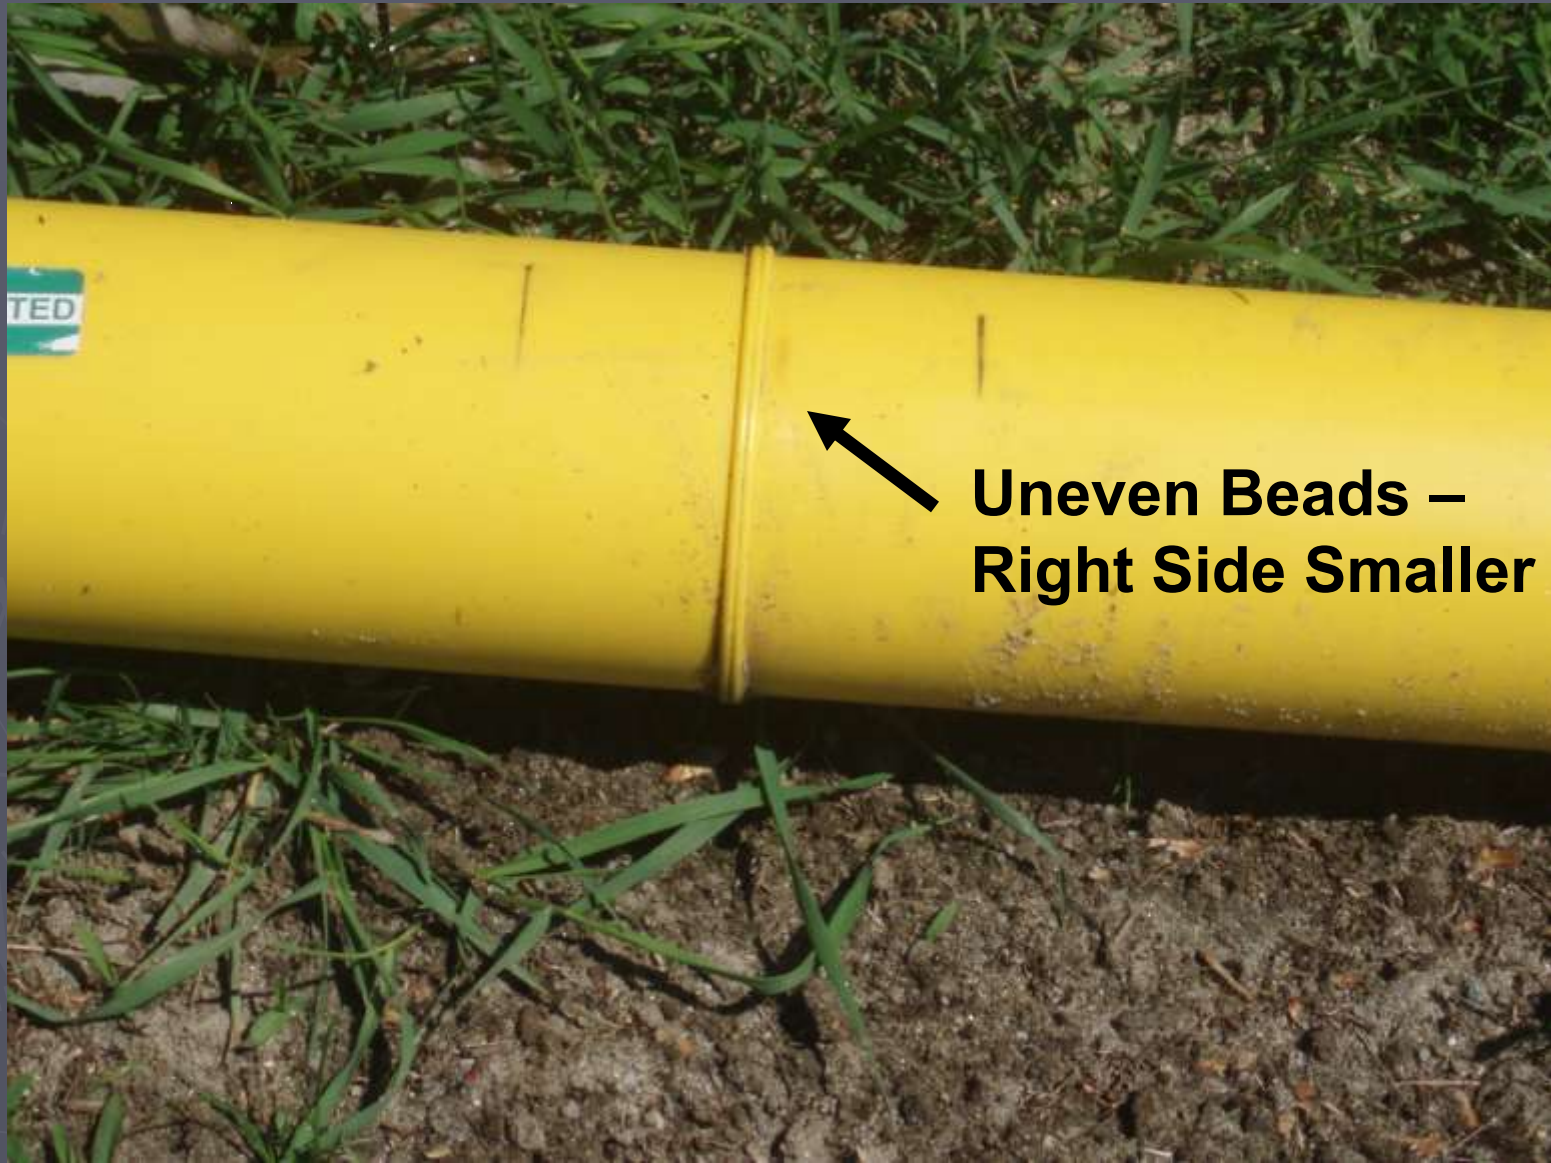
# Butt Fusion of Factory Ends

- ▶ **An abnormal High-Low is often apparent; especially if both ends are not faced equally, or if a factory end is mated to a cut end.**
- ▶ **Solution: Cut off or face back the factory taper.**

**Uneven Beads –  
Right Side Smaller**

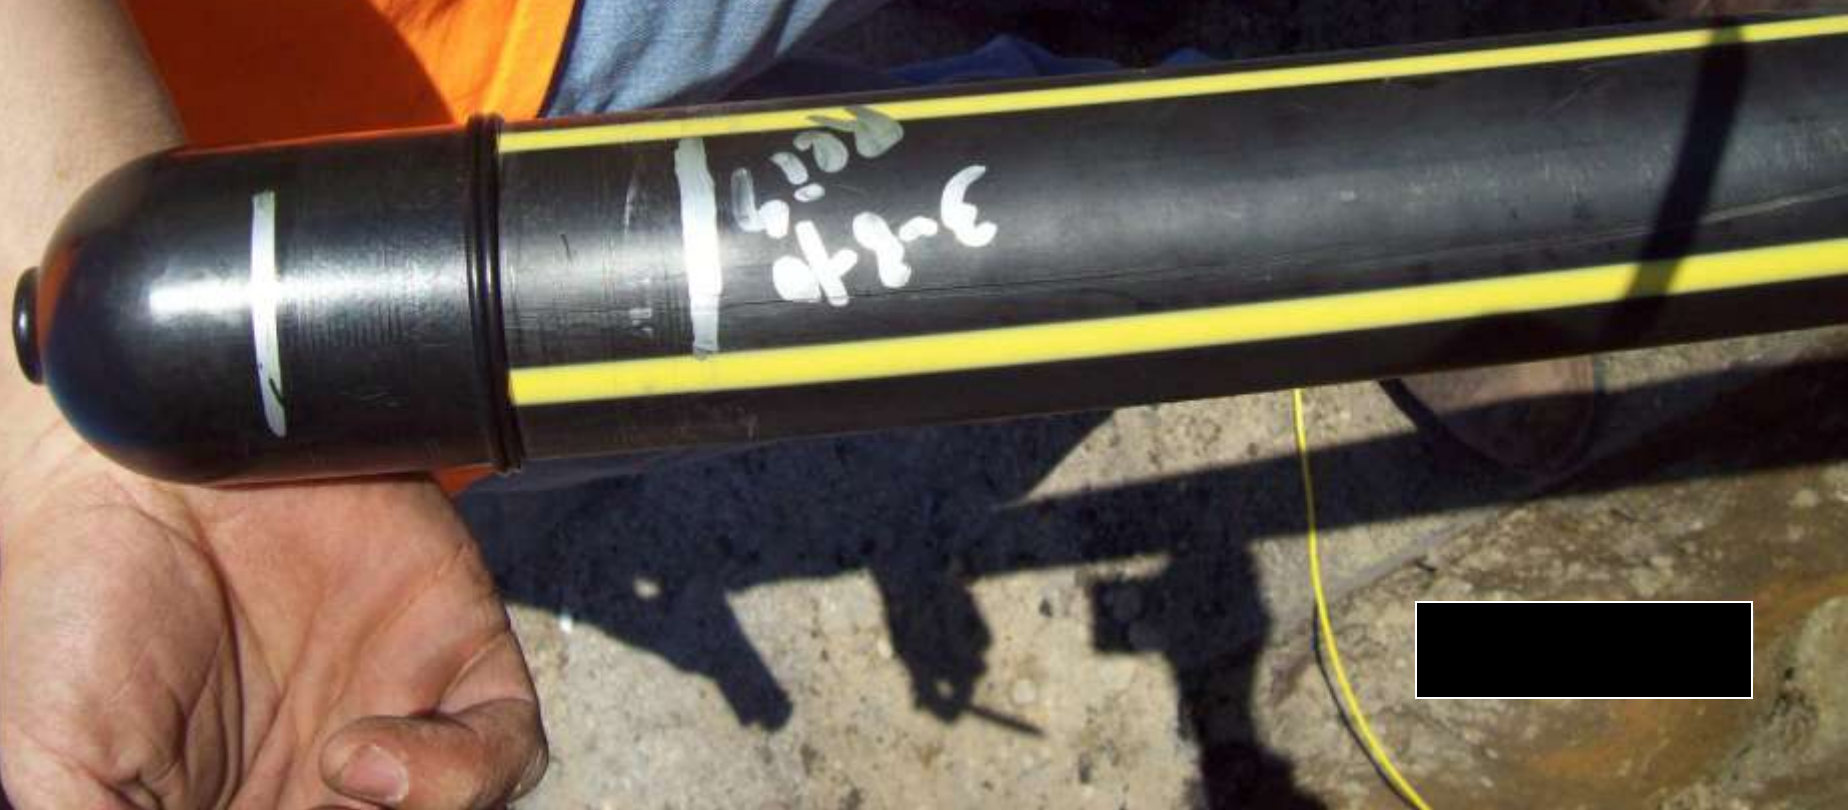
**Good example of marking the pipe before performing a butt-fusion to verify the pipe did not slip in the clamps.**

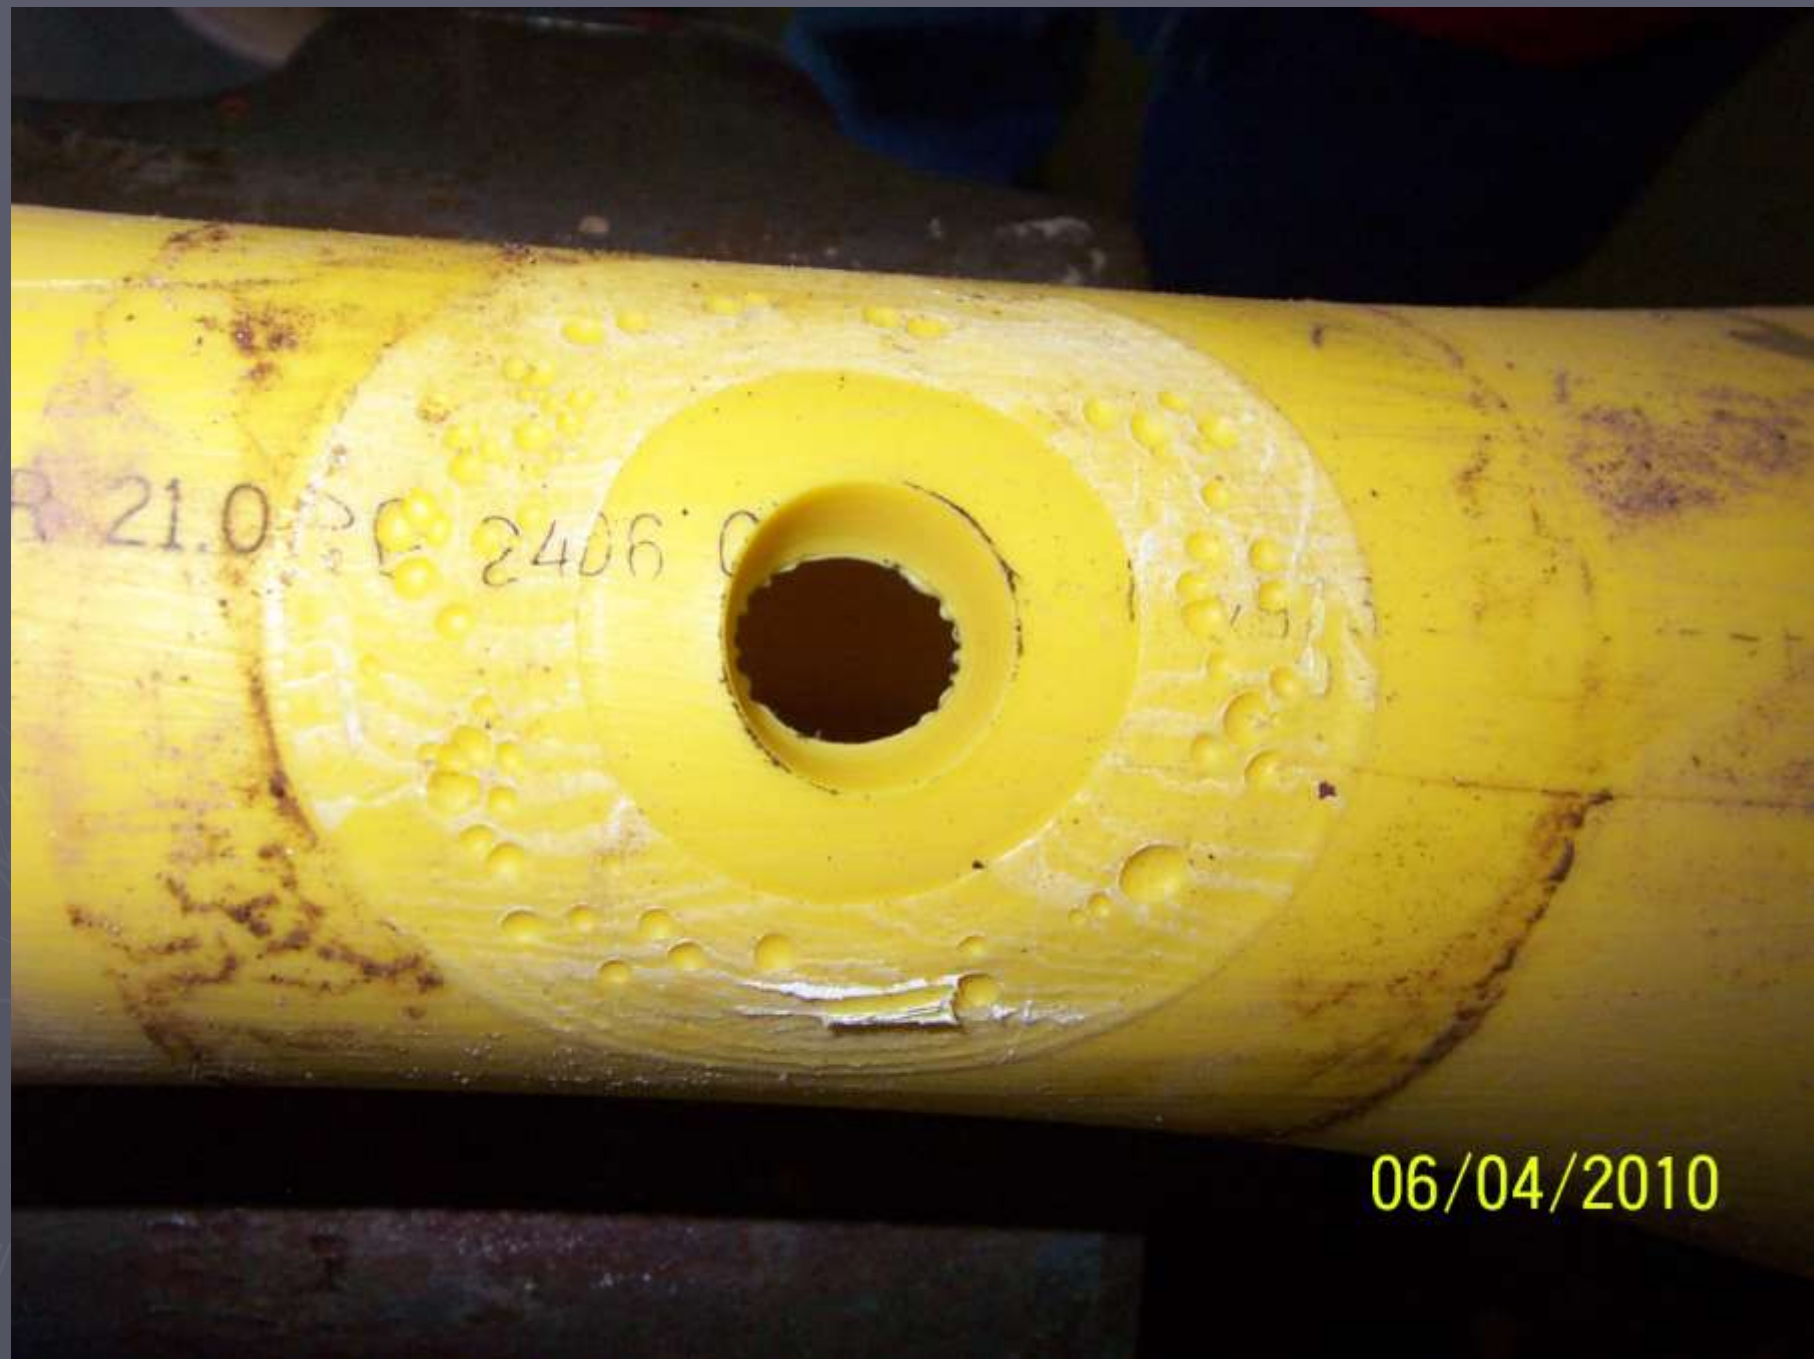
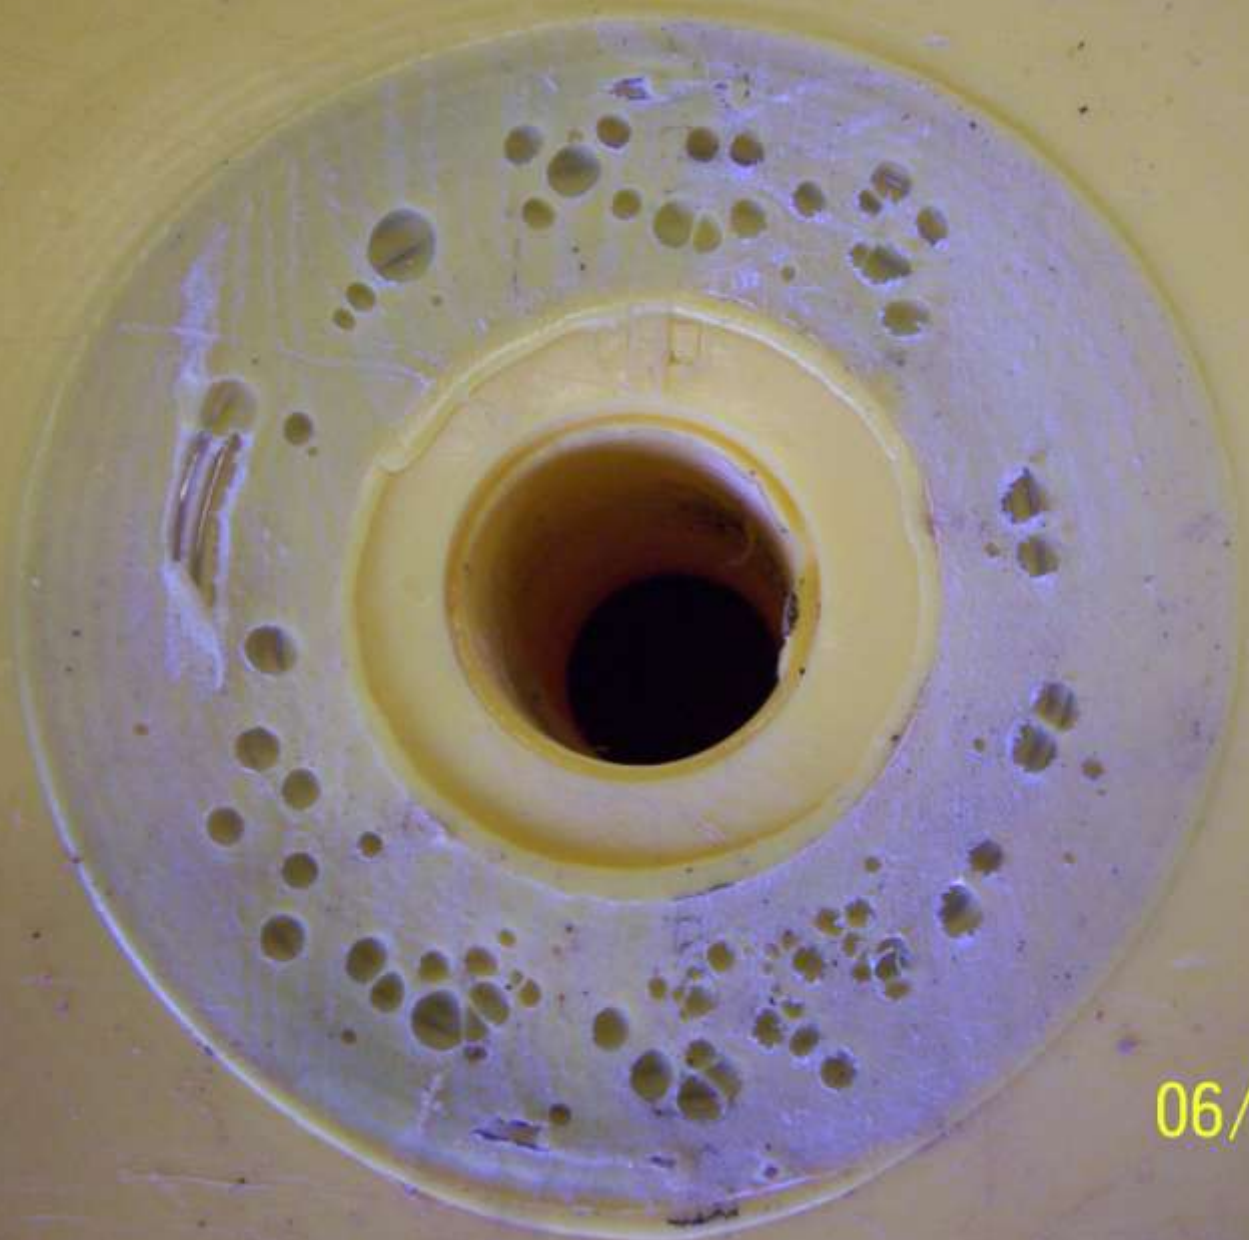
- **During an inspection of electrofusion tees, the inspector was concerned that the pipe was not scraped at all**
- **Later determined that a minimal amount of scraping had occurred**
- **Destructively tested 6 joints of concern – 5 failed**
- **Excavated many electrofusion joints**
- **Paint scrapers no longer allowed**

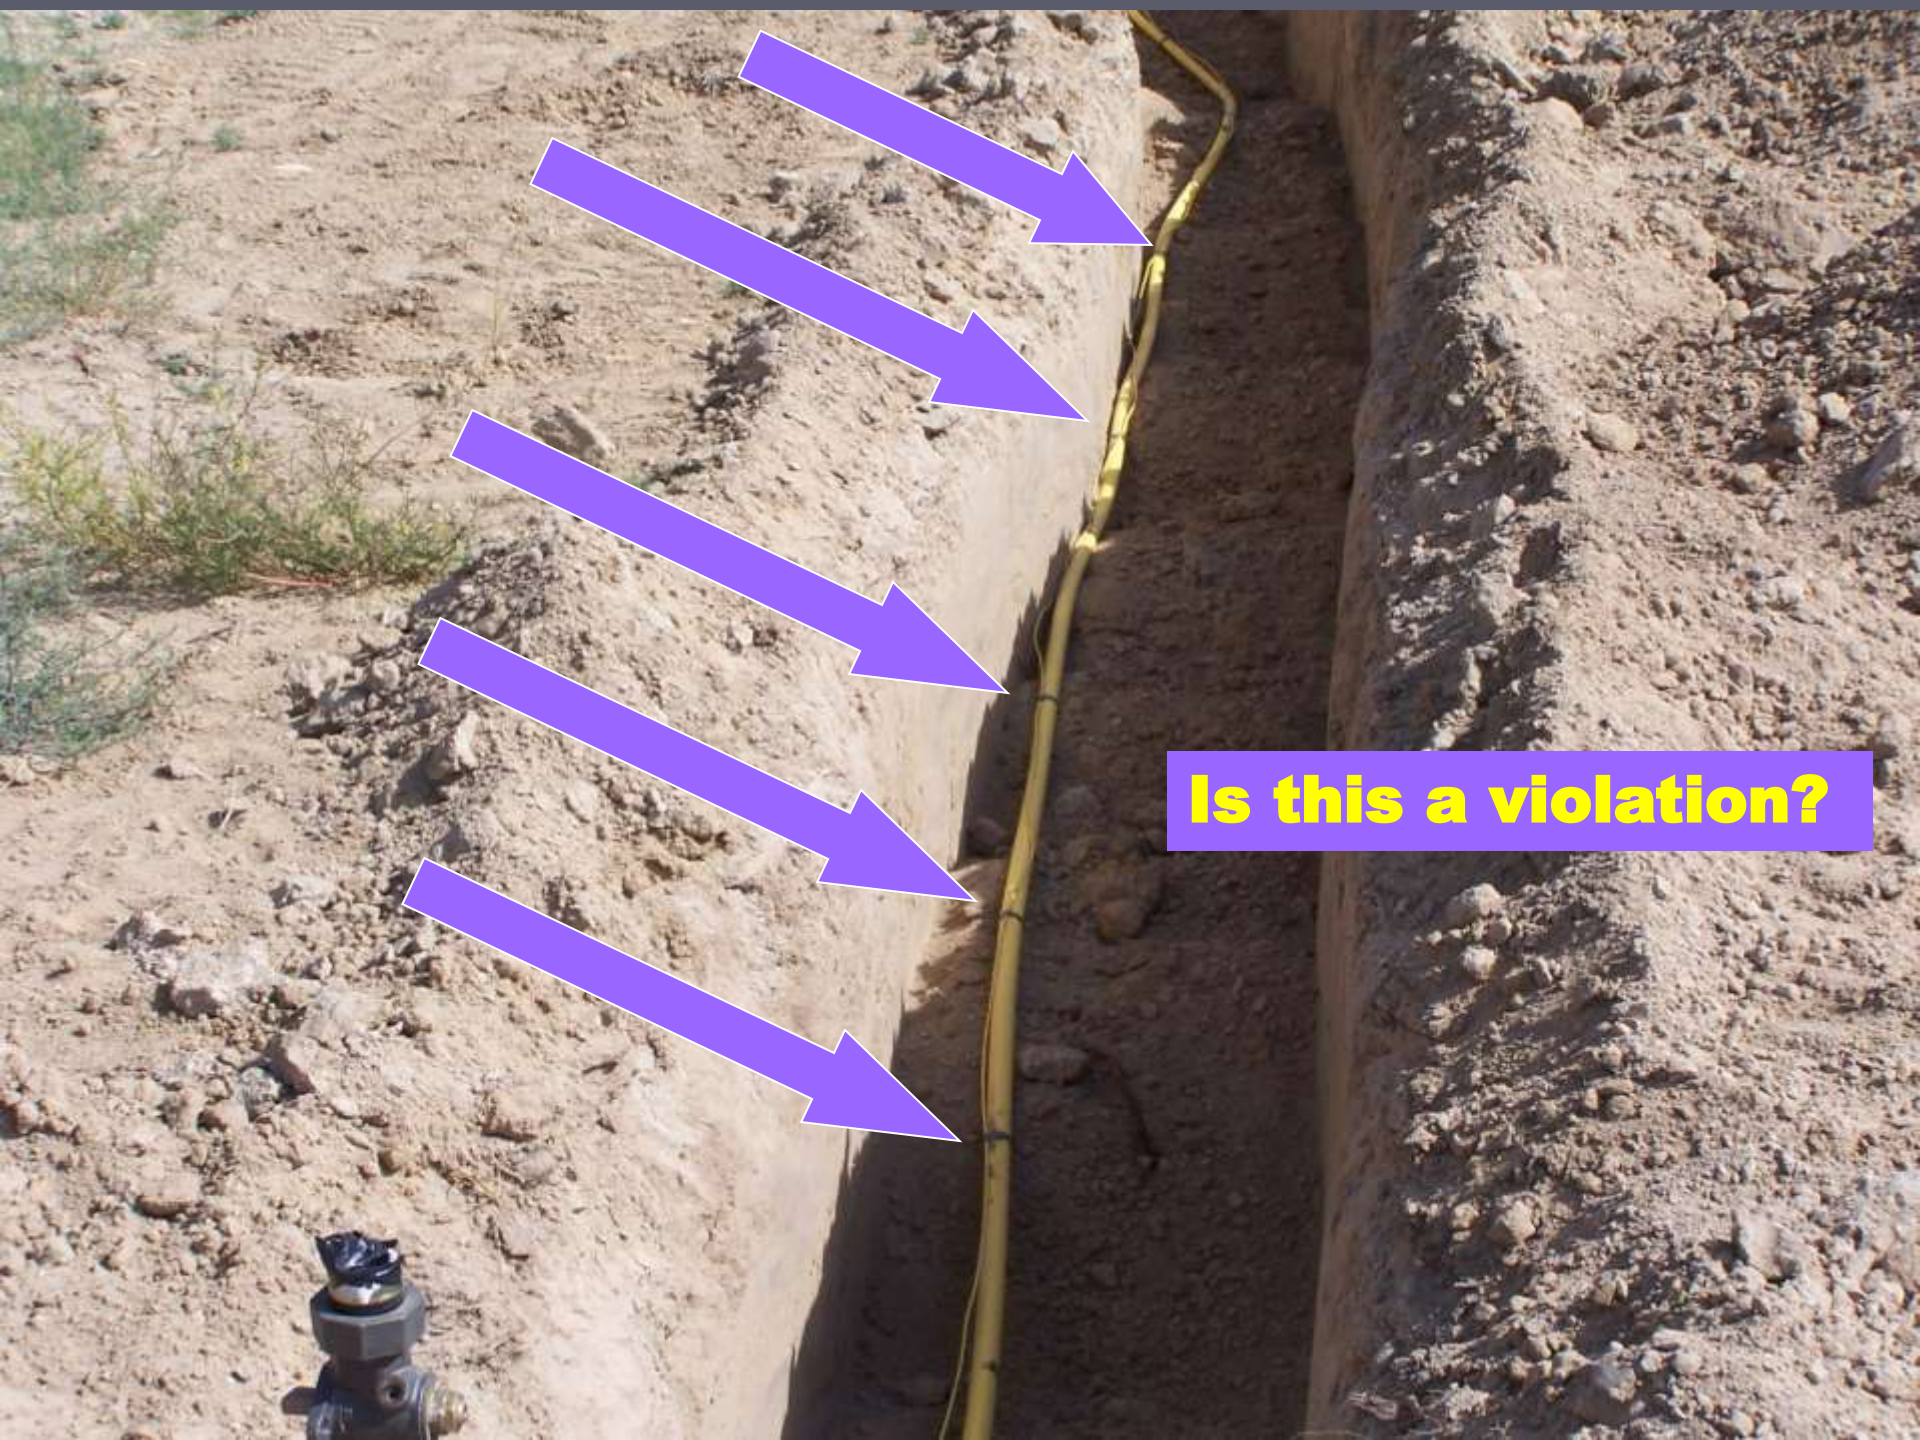
**...tracer wire may not be  
wrapped around the pipe and  
contact must be minimized, but  
is not prohibited**

**Is this a violation?**

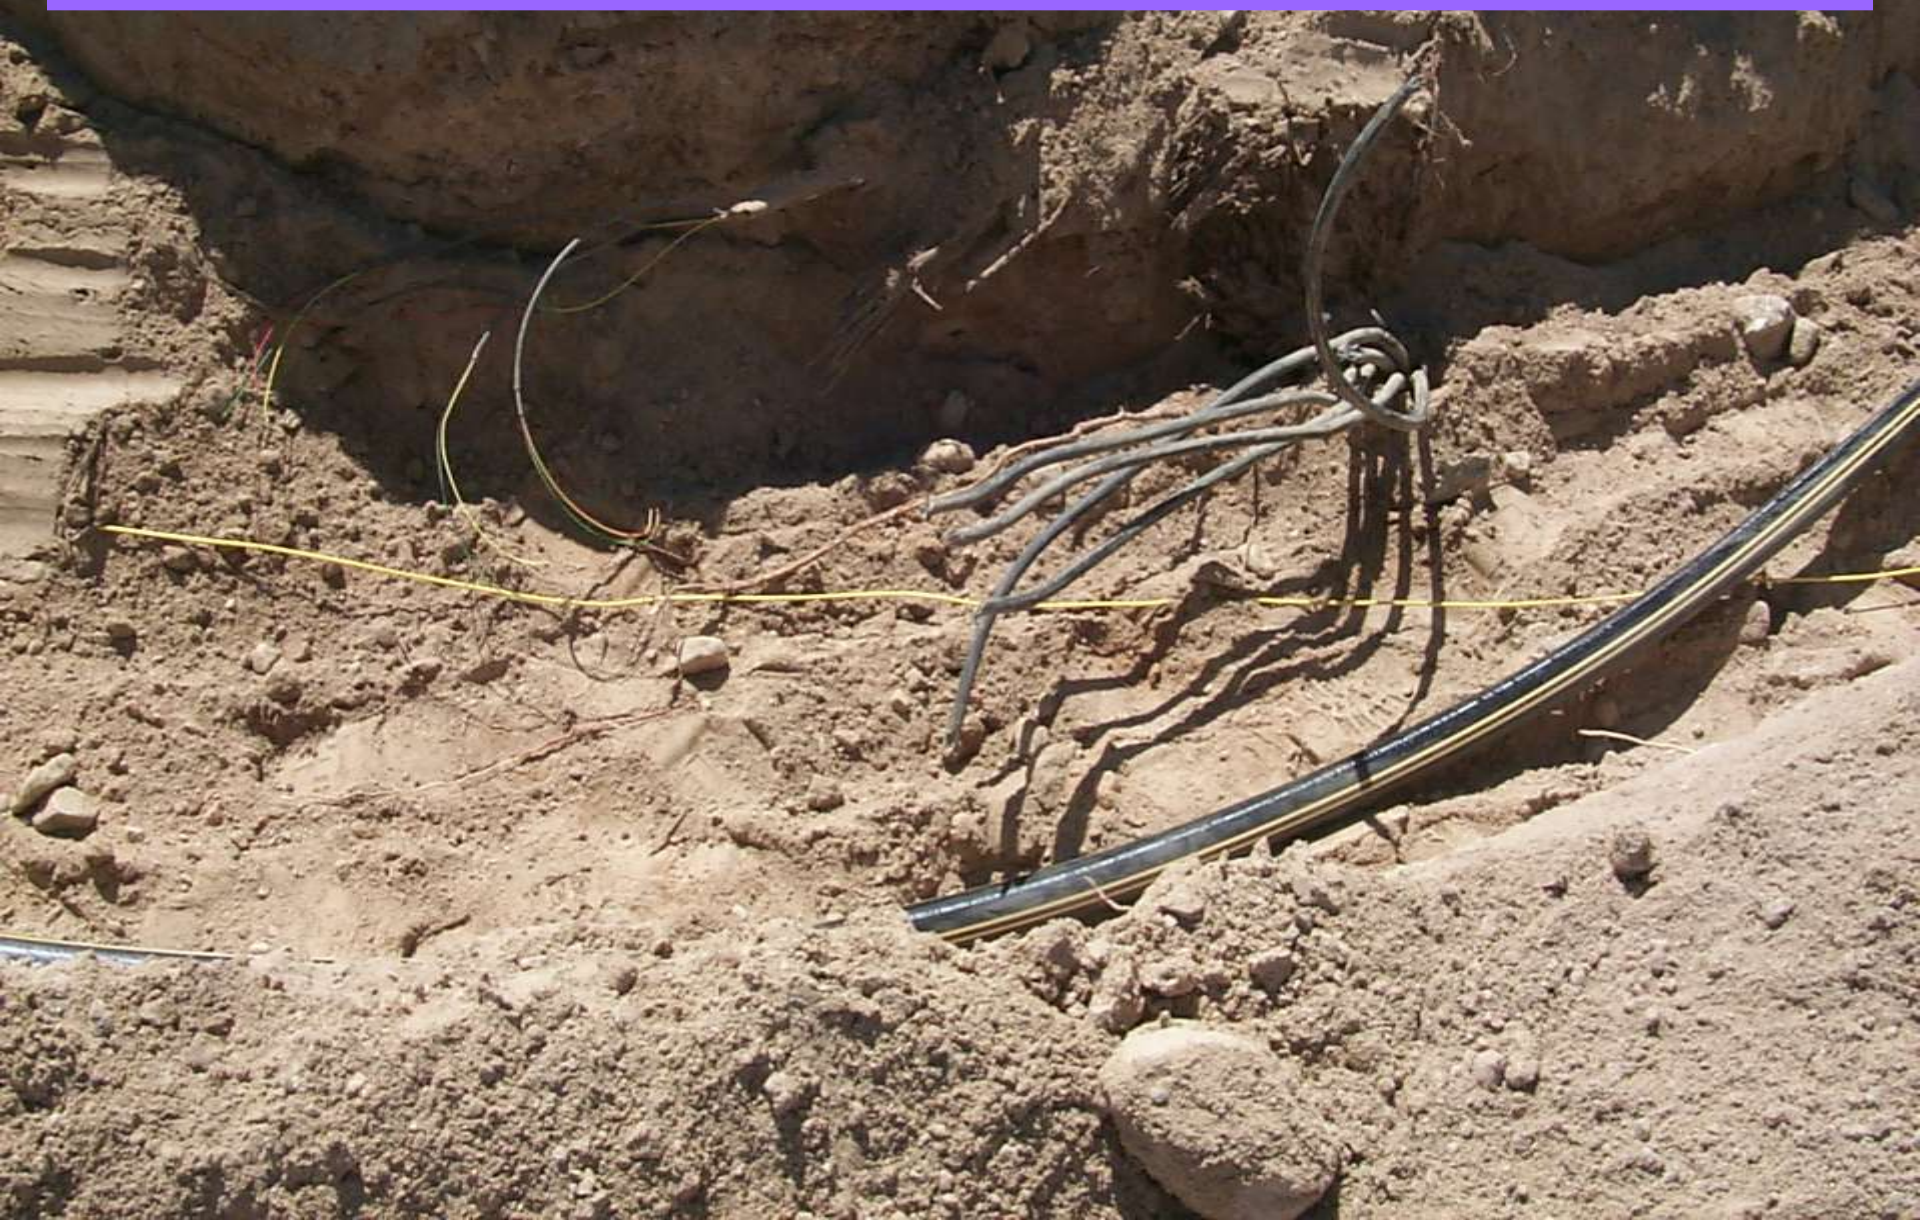
**How is this line going to be marked?**

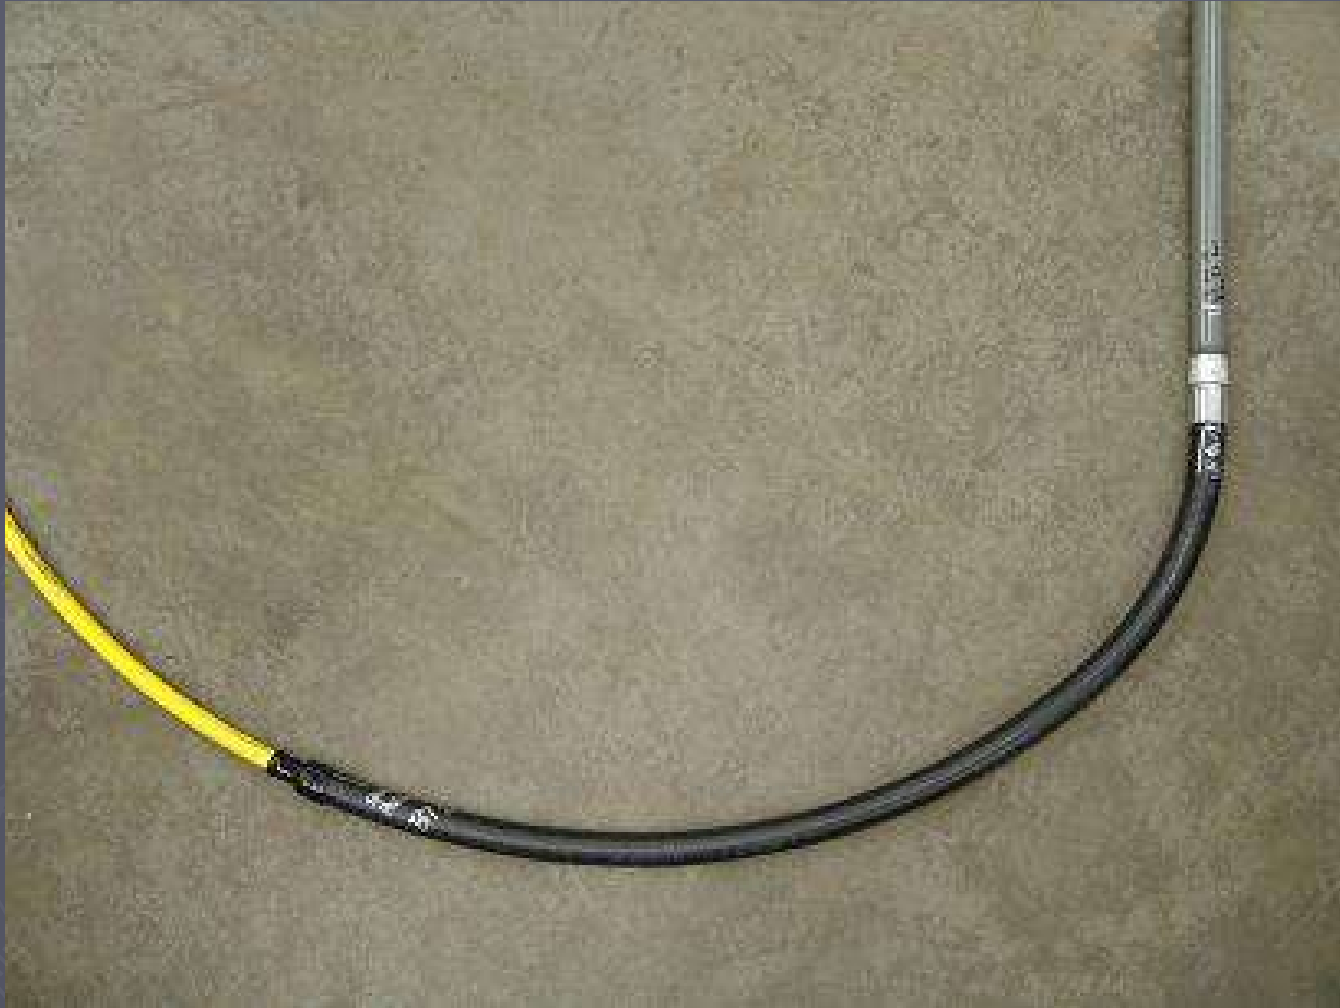
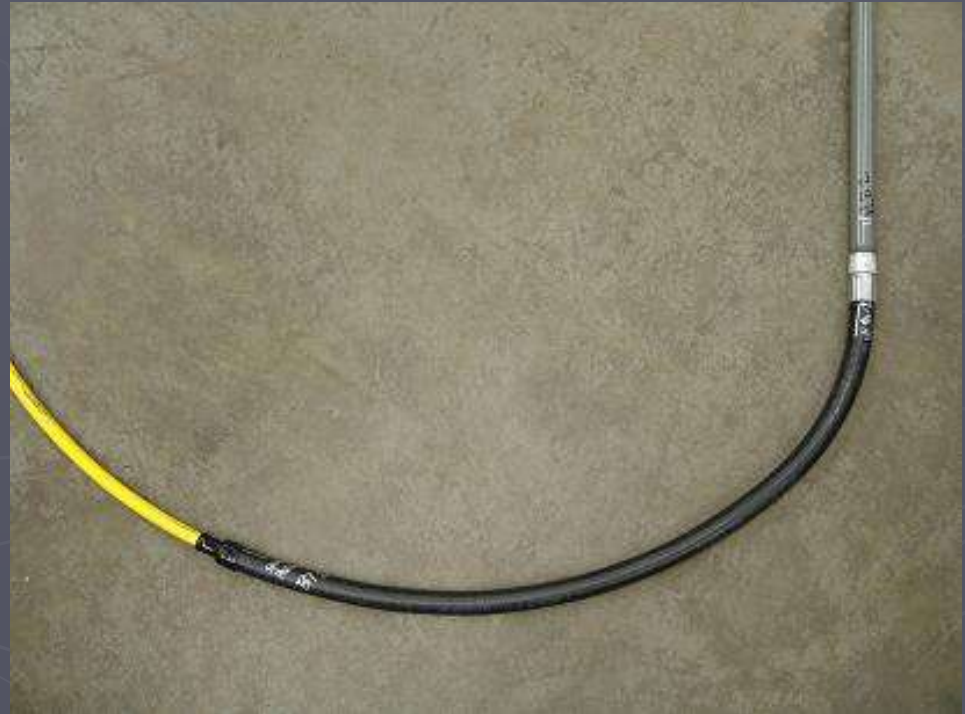
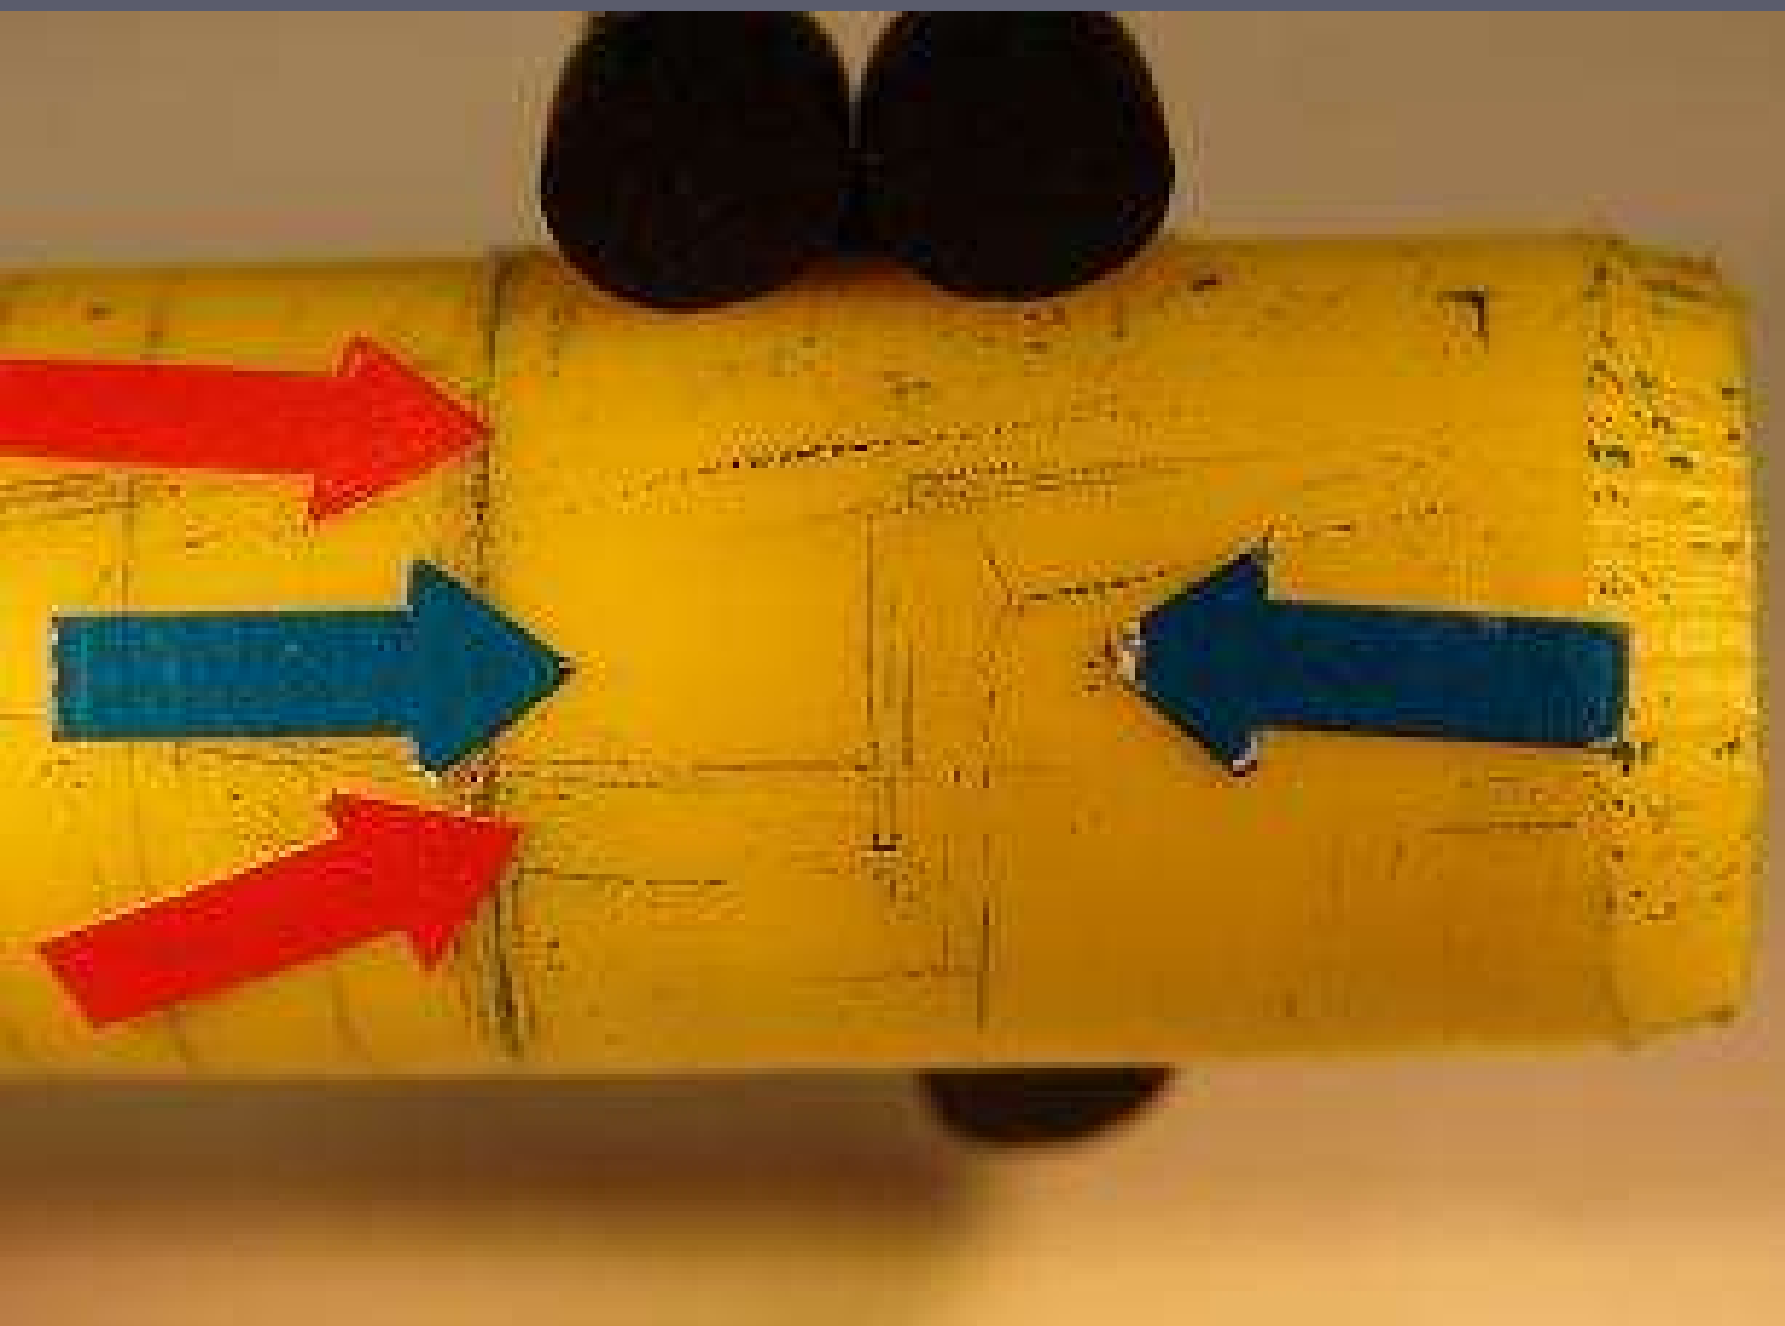
- **This time the Operator had a written procedure to assemble anodeless risers but unfortunately the parts supplied were leading to on site failures.**

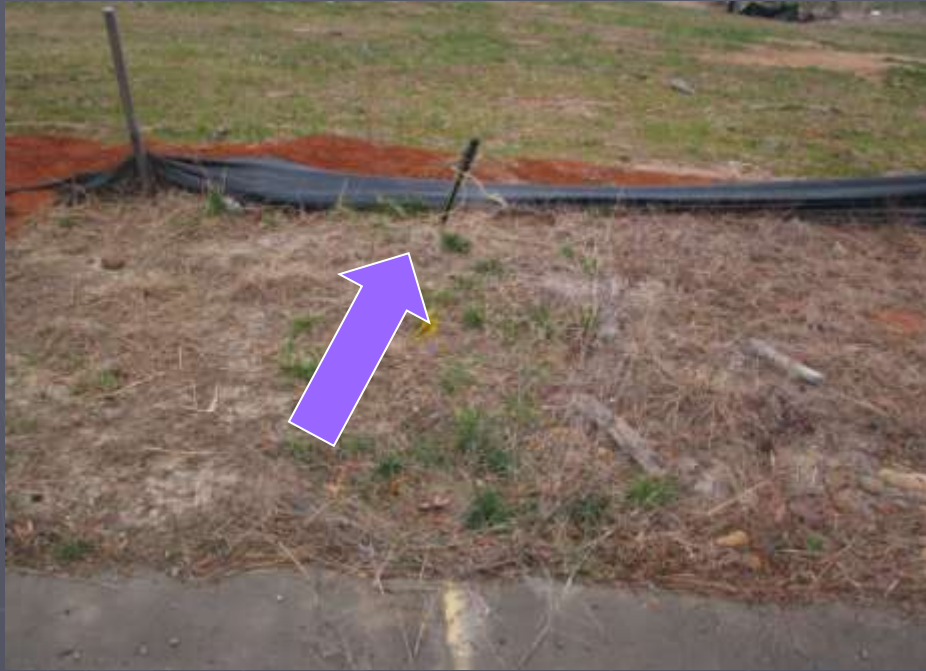
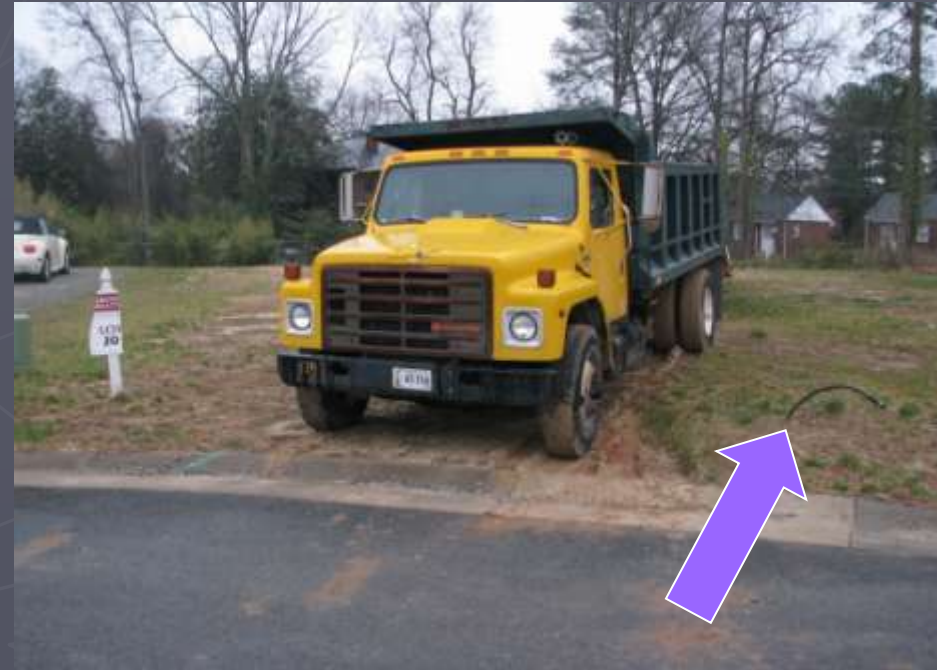
- ▶ **The Operator's contractor installed service stubs above ground that were left above the ground for several years.**

**§192.375(a)(i) - Failure to install a service line in a manner to protect the above ground level part of a plastic service from deterioration and external damage.**
